Risk of Nickel Sulfide presence in glass

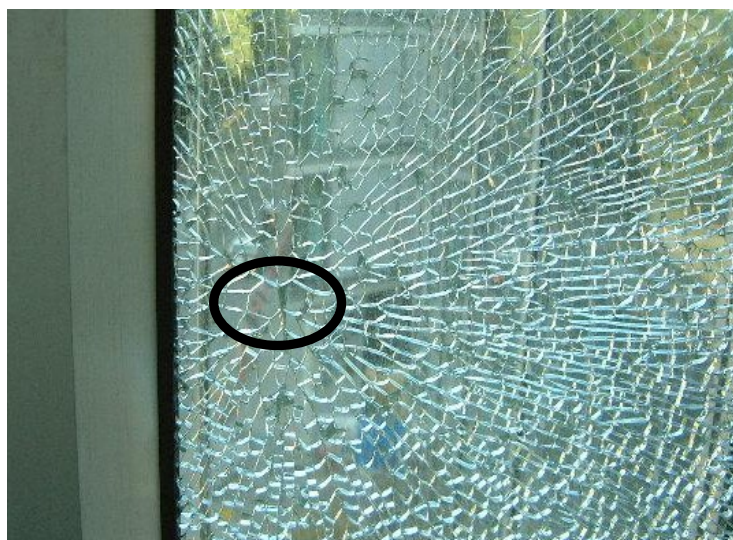
In this case, we find a characteristic breakage in the shape of butterfly. Many articles and publications exist on the subject. The phenomenon is inherent to thermally toughened glass, and can therefore not be considered a hidden defect of the product.

Typical breakage starting from a NiS inclusion

- 1) If the thermally toughened glass is necessary for your application, we can opt to choose heat strengthened glass instead of tempered glass which can reduce the risk of spontaneous breakage. However, please mind that heat strengthened glass has also possibility of spontaneous breakage.
- 2) If the tempered glass is necessary, a process called "heat soak" treatment should be strongly recommended. This one consists in placing glass in a furnace at a stage of temperature, during a determined time, in order to enable and accelerate the transformation of NiS. The breakage due to the possible presence of critical particles of NiS will partially occur during this treatment. Please mind that "heat soak" treatment cannot fully eliminate the risk of spontaneous breakage. The "heat soak" treatment methods are described in several standards such as EN 14179 and ASTM.
